**Flood Control Project Maintenance
Levee Inspections**

Fall 2012 Levee Maintenance Deficiency Summary Report

Sutter Maintenance Yard Hamilton Bend

Waterway			Bank	Unit Miles
Unit No. 01 Feather River Hamilton Bend			Right	3.22
	Spring (March - May)	Summer (June - August)	(September - November) Fall	Winter (December - February)
Unit Maintenance Rating (Fall Only)			A	
Date of Inspection	03/28/2012 - 03/28/2012		09/25/2012 - 09/25/2012	
DWR Inspector	Clay Thomas		Clay Thomas	
Accompanied By	Jason Cooper Sutter Yard		Jason Cooper Sutter Yard

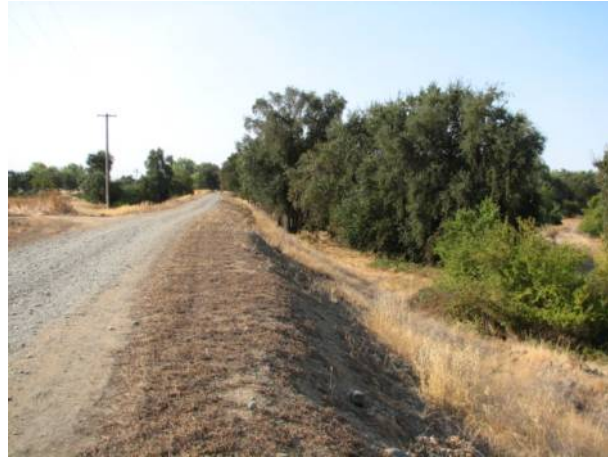
cathom_f_20121005_205.JPG

Levee Mile Report Line	4
Start Levee Mile	0.01
End Levee Mile	1.20
Location	Land Side
Category	Earthen Levee
Item	Vegetation

This photo is of the landside slope of the levee at levee mile 1.20, looking downstream.

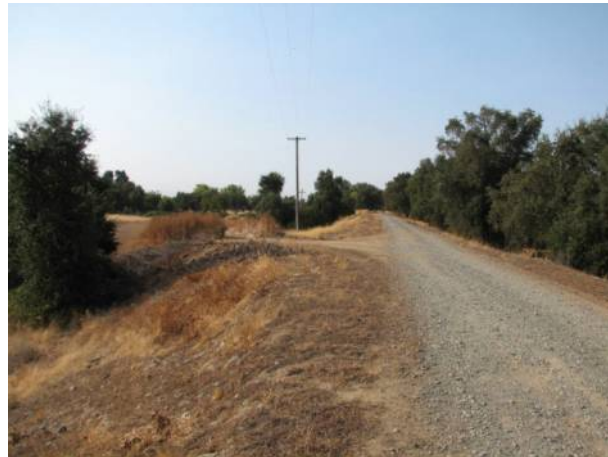
cathom_f_20121005_206.JPG

Levee Mile Report Line	5
Start Levee Mile	0.01
End Levee Mile	1.20
Location	Water Side
Category	Earthen Levee
Item	Vegetation

This photo is of the waterside slope of the levee at levee mile 1.20, looking downstream.
